Land at Clifton Gate, York.

John Thompson & Partners

Date: 5th April 2014

Reference: BA4226

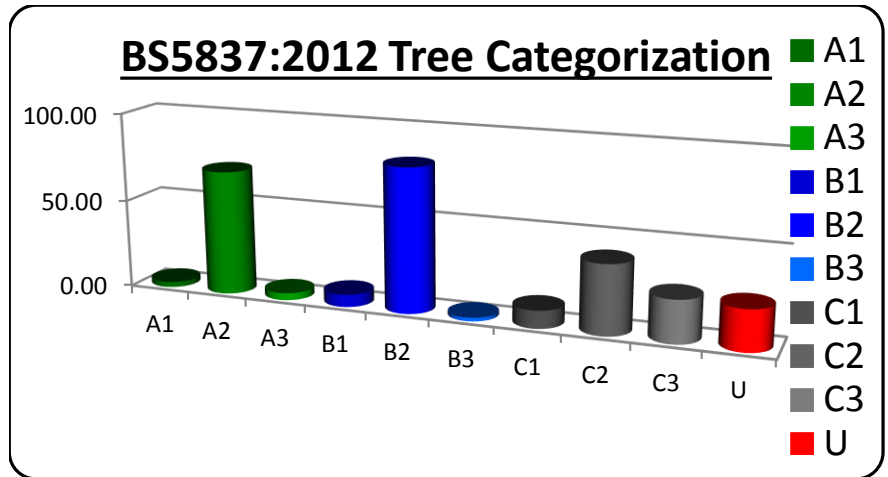
2.9.3 The graph opposite provides a breakdown of the 236 trees and groups, the tree categories on the site shows the trees to have a predominately landscape and conservation value. With the individual category's totals being:-

- Category A = 77 Tree**
- Category B = 90 Trees**
- Category C = 73 Tree**
- Category U = 23 Trees**

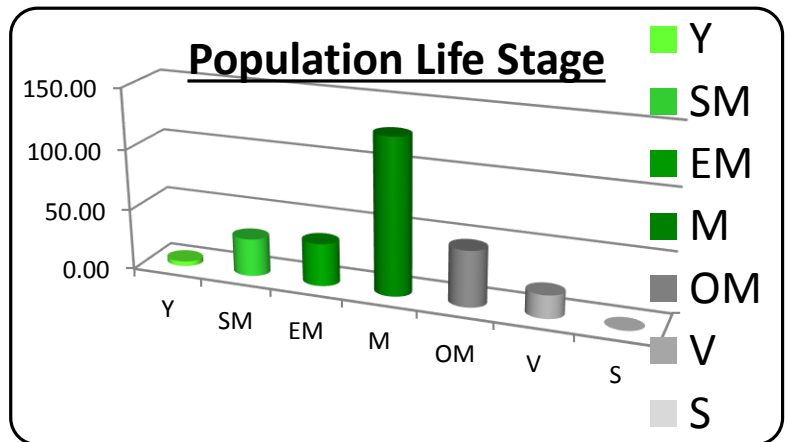
2.10 **Age Class.** The trees on site are predominately mature though a wide range of age classifications are present, which is typical for such a large group distributed over such a large area. Which points to the site has having had reasonable tree management over recent times.

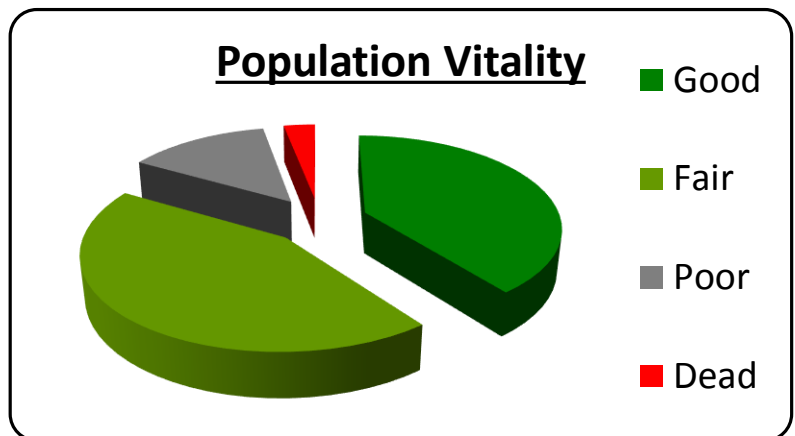
2.11 **General Health.** The trees on site have a predominantly fair to good condition, which is better than expected for such a location and in light of the recent site changes. This suggests that the tree population as a whole is reasonably robust and is well placed to withstand or not to be negatively affected by site or environmental changes.

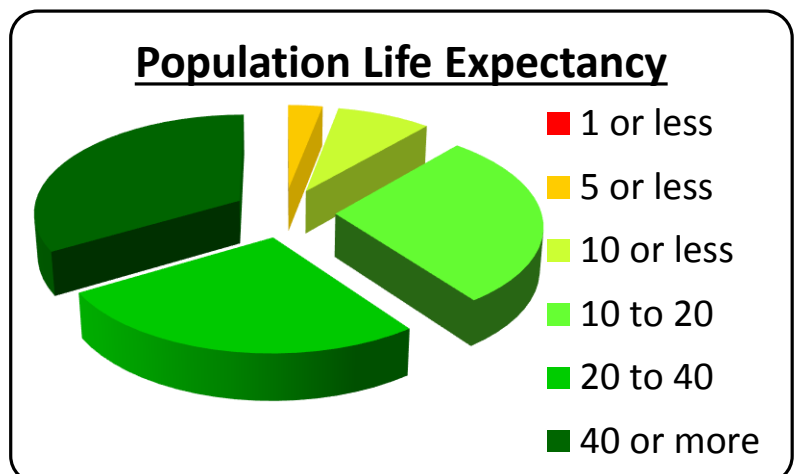
2.12 **Life Span.** An assessment of the population's life expectancy shows that trees on site have a reasonable potential with only around 60% of the trees having an expected safe life of greater than 20 years, which underlines the trees current good condition.
