Access Audit City of York Council Chambers City of York Council St Martins Courtyard Coney St York, YO1 9QL

12th August 2022

About Access Ltd

Version: Final

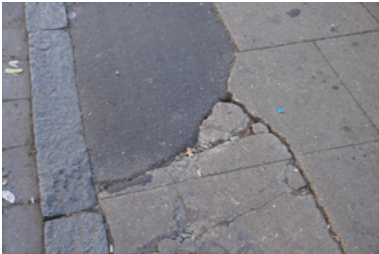
Ref	Current Findings	Recommendation	Priority
2.1.3	<p>The footways have a surface that is a mix of concrete and stone pavers along with brick setts. These do not always provide an even surface. This can lead to slips and trips.</p>

<p>A section of paving that could cause a tripping hazard.</p>	The council should regularly review paving for unevenness and make good as and when required.	M

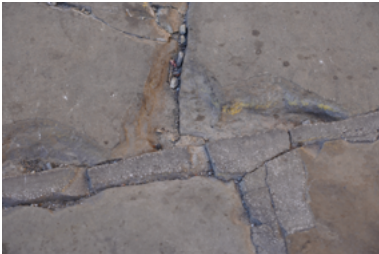
2.2	Coney Street to the site entrance		
2.3	This is a pedestrianised street with limited access for vehicles.		
2.4	<p>This has a surface with a mix of concrete pavers and block paving. These do not always provide an even surface. This can lead to slips and trips.</p>

<p>A section of paving that could cause a tripping hazard.</p>	The council should regularly review paving for unevenness and make good as and when required.	M

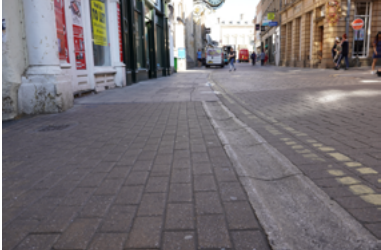
Ref	Current Findings	Recommendation	Priority
2.4.1	<p>A dished gully runs along one side of Coney St. These are problematic for a number of user groups, not least wheelchair users, mobility impaired and blind and partially sighted people. Gullies are difficult to travel across in a wheelchair, and can trap wheels if someone is moving parallel to them. For others, the gully is a tripping hazard. Dished gullies should not be used. When the public realm is upgraded the dished gullies should be replaced with a drainage system that has a flush surface.</p>

<p>A dished gully that can be an issue for some people.</p>	Replace dished gully with a flush surface drainage system.	P

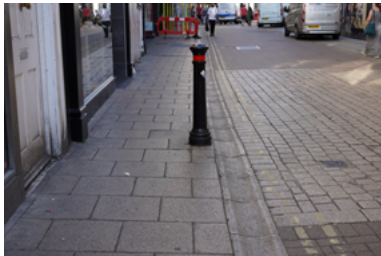
2.4.2	<p>Bollards can be found at random points along the route. These provide good tonal contrast against the background they are seen against and incorporate a tonally contrasting band to the top. They are placed towards the kerb edge. It is not readily apparent why these bollards are provided but they can be a hazard in a pedestrian zone where people walk across the full width of Coney St. Bollards should not be used unless absolutely necessary. We suggest these are removed unless there is a compelling reason for them to be retained.</p>	Remove bollards along Coney St unless absolutely necessary.	2

An example of a randomly placed bollard.

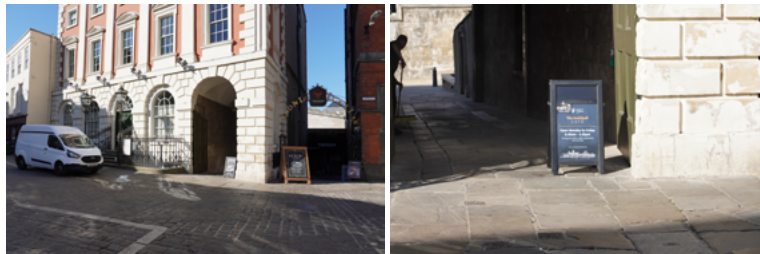
The Mansion House with the archway to the right of it and the A-board to the bottom right of the archway.

Ref	Current Findings	Recommendation	Priority
4.1.2	A-boards can be a hazard to many people as they are often unexpected within the access route. Another issue is that they are rarely placed in the same location day after day. A-boards should only be used when they can be placed outside of the pedestrian circulation routes.	Give consideration to other signage alternatives that don't obstruct the circulation routes.	2

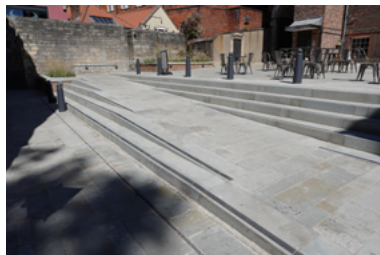
4.1.6 There is a 'stramp' in the Yard. Stramps blend steps and ramps and can prove hazardous to all users for various reasons, in particular wheelchair users, people using canes or crutches, people who are blind or have low vision, anyone who is distracted. Stramps do not provide the protection of handrails, level landings, appropriate gradients, and visual contrast. For example, a ramp should have handrails to both sides and have stands at least 100 mm each side to prevent people falling off. Steps should have even height risers (height of steps) and treads with a uniform depth. Because there is a gradient passing through the steps, the risers have uneven heights. This can lead to slips and trips. For these reasons, mixing these two features as done here is not recommended.

The steps and ramp within the Yard and uneven height risers.

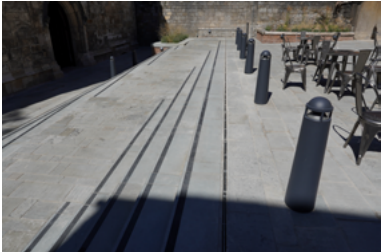
Ref	Current Findings	Recommendation	Priority
4.1.8	<p>Tactile warning: at the top and bottom of steps there should be corduroy hazard warning to advise people, particularly blind and partially sighted people, that there is a sudden change in level. In this instance this has not been provided. Tactile blister paving has been provided at the top and bottom of the flight of steps at the lower end of the ramp. This 'blister' style of tactile warning is for use at street crossing points. Using the incorrect tactile paving can lead to confusion and so this should be removed and replaced with the correct type.</p>

<p>No tactile warning at the top of the steps. 3976 Tactile blister paving at the top and bottom of steps in the lower end of the ramp.</p>	Provide corduroy tactile paving at the top and bottom of the steps.	1

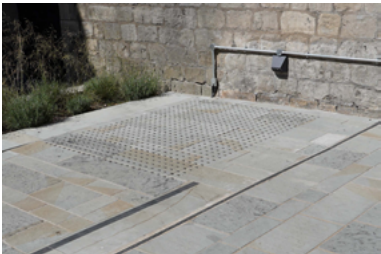
4.1.9	<p>Ramp: tactile blister paving has been provided at the top of the ramp. Tactile warning is not required at the top and bottom of ramps. However, tonal contrast is recommended. As this is a new feature it would have been feasible to use stone that contrasts tonally with the top and bottom of the ramp to meet with this design feature.</p>

<p>Tactile blister paving at the top of the ramp.</p>	Remove tactile blister paving at the top of the ramp and provide tonal contrast to the top and bottom landings.	P

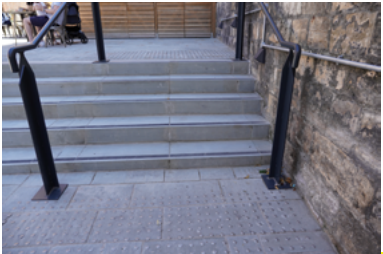
Ref	Current Findings	Recommendation	Priority
4.1.10	<p>Steps: there is a flight of steps with handrails to both sides at the bottom of the ramp. The handrails provide good tonal contrast against the background they are seen against and are at a height that meets with current guidance. However, the steps do not have even height risers, which they should. The bottom step has a height of approximately 110 mm and the remaining four steps have a height of 175 mm. Having uneven height risers can lead to slips and trips.</p>	Provide steps with even height risers.	1

<p data-bbox="712 798 1064 837">Steps with uneven height risers.</p>

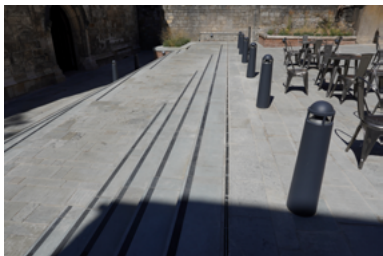
4.1.14	<p>The bollards are fitted with lights that illuminate the area. However, lighting at this height will be in the eyeline of people moving up the stramp. This can cause glare and impair people's vision, which could add to the tripping risk of the uneven height risers. We have not witnessed the lighting during the hours of darkness so this should be checked. The rule of thumb for lighting is that it should come from above or above head height.</p>	<p>If the bollards are not removed ensure the lighting from them does not cause glare and if it does, provide lighting that comes from above head height or above to illuminate the area and steps.</p>	1

Bollards with lighting included.

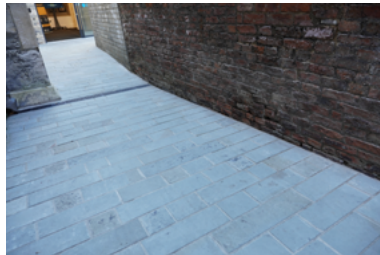
4.3 There are a number of inclines along the route from the Yard. The steepest of these can be found running alongside the Guildhall. This section of path leads directly to the Main entrance and has a maximum gradient of 1:12. Where gradients are 1:20 or steeper, to a maximum of 1:12, they should be designed to meet guidance for ramps. This includes the provision of handrails and landings that contrast tonally with the inclined surface. Providing level landings that contrast tonally with the incline may not be reasonable at this time.

A section of path with a gradient that is approximately 1:12.

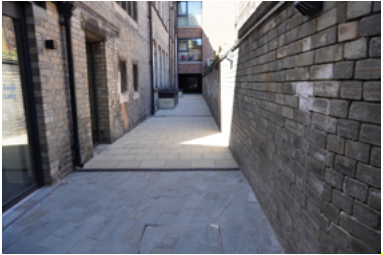
Ref	Current Findings	Recommendation	Priority
4.4	<p>There are a number of dark-coloured flush drainage channels along this route. There is a strong tonal contrast between the channels and the paving to either side, which to some people can create the illusion of a step edge or a change in level. As such, bands of strong tonal contrast in flooring can be an issue and should be avoided.</p>

<p>An example of a drainage channel with strong tonal contrast.</p>	<p>Investigate the feasibility of providing flush drainage channels that do not provide strong tonal contrast.</p>	3

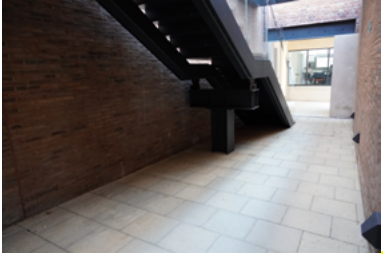
4.5	<p>A staircase leads to an open terrace area on the first floor. No guarding has been provided to the underside of the staircase, which is considered to be a hazard.</p>

<p>The underside of the staircase requires guarding to a height of 2500 mm.</p>	<p>Provide guarding to a height of 2500 mm to the underside of the staircase.</p>	1

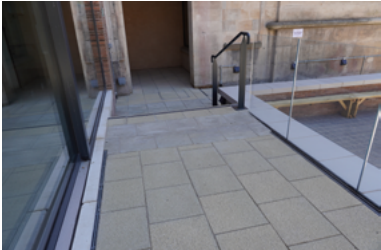
4.9	When first entering the garden, there is a flight of three steps. A handrail of a design and at a height that meets with current guidance has been provided to one side. Handrails should be provided to both sides of flights of steps; this allows people to use the steps in either direction, regardless of which side of their body they need to use to support themselves. There is a second flight of steps within the garden that has handrails to both sides and the centre.	Provide a handrail to the opposite side of the steps to the existing handrail.	2

Steps with handrail to one side only.

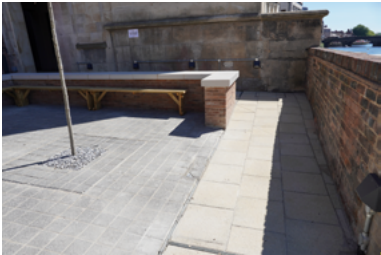
4.11	A ramp has been provided as an alternative access route that avoids the steps. The top section has a typical gradient of 1:21. This means it is seen as a slope rather than a ramp and so handrails and contrasting landings are not required. However, this route turns through 90° and the bottom section has a gradient of approximately 1:12 for 1300 mm. This gradient and length means this section is a ramp, and so handrails and tonally contrasting landings should be provided, which they are not.	Provide handrails to both sides of the bottom section.	2

<p>Bottom section of the ramp.</p>

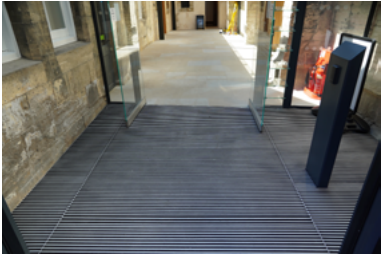
Ref	Current Findings	Recommendation	Priority
5.1.3	<p>The lobby has a weather mat with a pattern that combines black and silver bands. This is visually noisy (has random visual stimulus) and so will be an issue to blind and partially sighted people and to some people who are neuro diverse. A weather mat of a single colour and with a similar light reflectance value (LRV) to that of the flooring either side of it should be provided.</p>	<p>Replace weather mat with a design that is visually calm.</p>	2

<p>Visually noisy weather mat.</p>

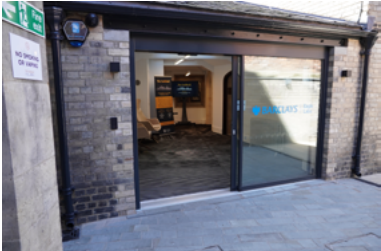
5.3.4	The door and side panel have a large area of glazing with manifestation. The name and logo of 'Barclays' is applied across the fixed side panel in blue text and single-coloured dots serve as manifestation on the sliding door. It is recommended that manifestation of two tonally contrasting colours is provided.	Provide manifestation of two tonally contrasting colours.	3

Main entrance with coloured manifestation.

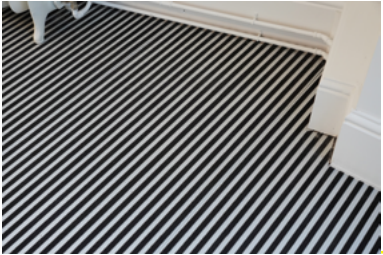
Ref	Current Findings	Recommendation	Priority
5.3.5	<p>The lobby has a weather mat with a pattern that combines black and silver bands. This is visually noisy (has random visual stimulus) and so will be an issue to blind and partially sighted people and to some people who are neuro diverse. A weather mat of a single colour and with a similar LRV to that of the flooring either side of it should be provided.</p>

<p>Example of the matting at the entrance.</p>	Replace weather mat with a design that is visually calm.	2

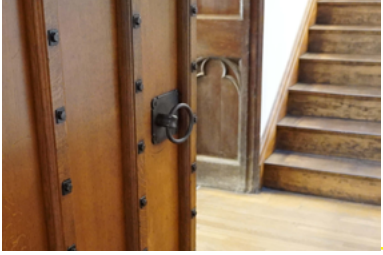
<p data-bbox="712 432 974 459">Ring handle to the door.</p>		
6.5	<p data-bbox="315 518 1041 742">From the lobby area of the main stairs: original wooden doors lead into the space. These provide ring handles which will be difficult to operate with a clenched fist. Again, it is likely these are original features. However, it should be investigated to see if they could be replaced with handles that can be operated with a clenched fist.</p>	<p data-bbox="1122 518 1814 662">Investigate the feasibility of replacing the ring handles with ones that can be operated with a clenched fist or provide a management solution of providing assistance as and when required. This will be subject to listed building consent.</p>	2

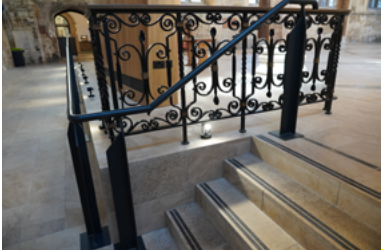
Ref	Current Findings	Recommendation	Priority
6.8	<p>The steps provide even height risers and treads with a uniform depth. The treads are approximately 20 mm less than the recommended minimum depth of 280 mm. It is not seen as reasonable to alter this. A handrail in the recommended height range has been provided to both sides. Tonally contrasting nosings have not been provided that meet with current guidance, as there are only markings to the treads and not on the risers. Nosings should contrast to both the tread and the riser and measure 55 mm on both.</p>	Provide contrasting nosings to meet with current guidance.	3

<p>Nosings not correctly marked.</p>

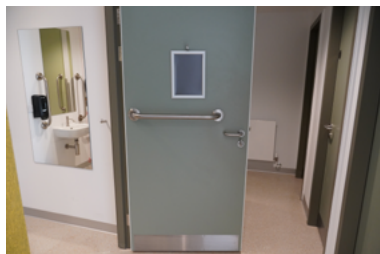
Horizontal rail to the back of the door is too high.

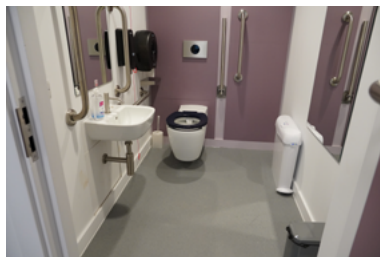
The accessible WC on floor 2a which measures 1430 mm wide x 1880 mm deep.

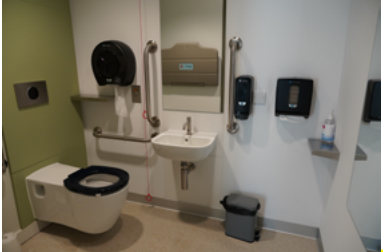
Ref	Current Findings	Recommendation	Priority
9.3.6	<p>If someone is able to reach the wash-hand basin, it's unlikely they can wash and dry their hands because the soap and paper towel dispensers are out of reach, see "Appendix 9. Accessible WC for Independent Use - elevation" on page 86. These should be positioned where the mirrors can currently be found above the wash-hand basins.</p>	<p>Reposition soap and paper towel dispensers to meet with current guidance.</p>	QW

<p>Mirror is positioned where the soap and paper towel dispensers should be.</p>

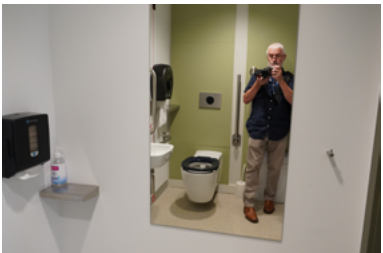
Ref	Current Findings	Recommendation	Priority
9.3.10	The recommended shelves have been provided.		
9.3.11	The toilet seats provide good tonal contrast against the WC pans.		
9.3.12	There are emergency pull cords with bangles at the recommended height ranges, and alarm reset buttons that are correctly positioned.		
9.3.13	Two clothes hooks have been provided at the recommended height ranges.		
9.3.14	<p>Events space: a mirror has been provided on the wall directly opposite the WC pan. Although this meets with guidance regarding its height range, the position is far from ideal. Few people like to see themselves sat on the toilet and some, those with dementia for example, could find it confusing and distressing because they don't recognise the reflection as themselves.</p>

Mirror directly opposite the WC pan.

Reposition mirror to the side wall.	3

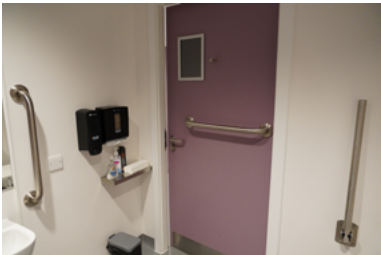
Ref	Current Findings	Recommendation	Priority
9.4	Combined accessible WC and shower		
9.4.1	This is located on the ground floor near the offices.		
9.4.2	The door is obvious and the door furniture can be operated with a clenched fist. The handle also provides good tonal contrast against the background.		
9.4.3	The door provides the recommended CEW.		
9.4.4	There is a horizontal pull rail on the back of the door but this is too high. It should be at a height of 680 mm above the floor.	Lower horizontal rail on the back of the door to a height of 680 mm above the floor.	QW

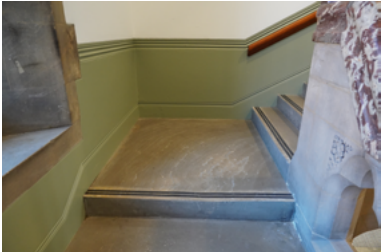
Ref	Current Findings	Recommendation	Priority
11.2	The stairs provide even height risers and treads with a uniform depth.		
11.3	<p>The stairs have a solid balustrade to the right side when climbing. Though people using the stairs could use the balustrade for support, it cannot be considered a handrail because it's too large for a hand to wrap around it. A handrail has been provided on the wall side at a height that meets with guidance and provides good tonal contrast with its background. This handrail is only provided on the main parts of the stairs and not where there are single steps to intermediate landings. Handrails should extend across all landings so a person does not have to let go when using the stairs. Providing a handrail to pass in front of the window at the intermediate landing may not be feasible. At the start and end of the flights the handrail should extend horizontally for a minimum of 300 mm; this is to allow people to take support from the handrail while still on level ground and indicates to blind and partially sighted people where the stairs start and finish.</p>	Provide a handrail which extends horizontally beyond the first and last steps by a minimum of 300 mm. This will be subject to listed building consent.	2

<p>Handrail does not extend around the landings.</p>

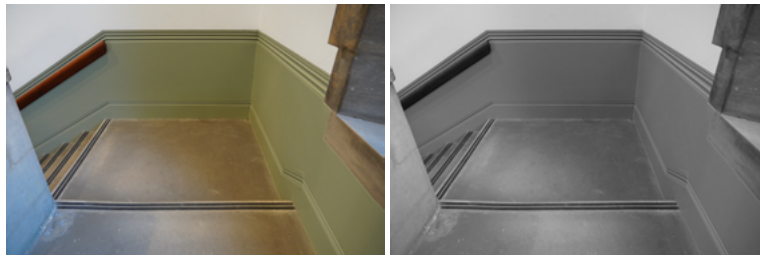
Colour and black-and-white photographs show the lack of tonal contrast.

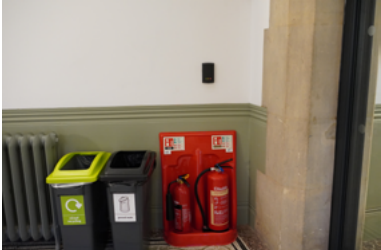
12.2	The doors leading into this area are located in the lobby of the main staircase and are activated by use of a proximity reader. Though the proximity reader is at an acceptable height, access to it is obstructed by recycling bins and a fire extinguisher station.	Provide unobstructed access to the proximity reader.	M

<p>Access to the proximity reader is obstructed.</p>

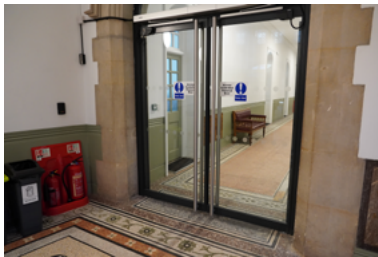
The proximity reader is located within the door swing.

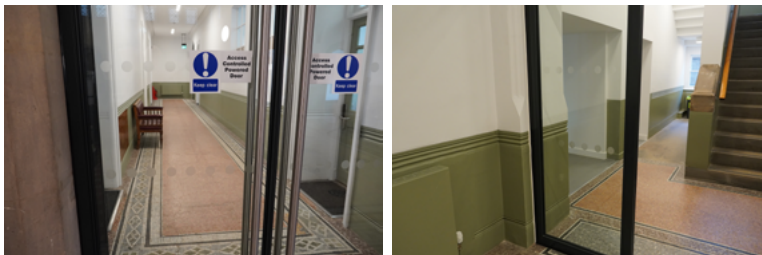
Manifestation to doors can be easily lost in the background.

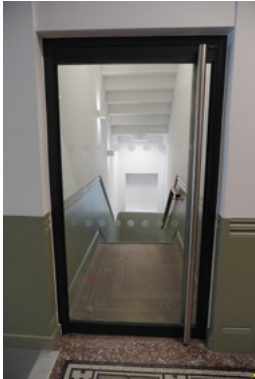
16.2	The doors closest to the main staircase are secured on magnetic locks in the same way as those on the ground floor.		
16.3	The doors are fully glazed with manifestation of round dots of one colour at two heights. Manifestation should be clearly visible when approaching the door from either direction. Guidance recommends that the use of two tonally contrasting colours should be provided, so if one colour is lost the other should still be visible.	Provide manifestation of two tonally contrasting colours.	3

<p>Door leading to Stair 5 with manifestation that is not readily apparent.</p>

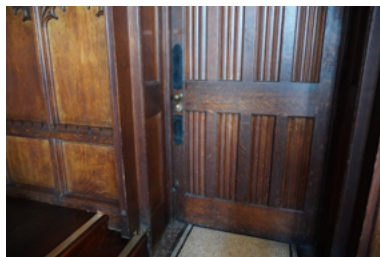
Door handle in the corner with obstructed access to it.

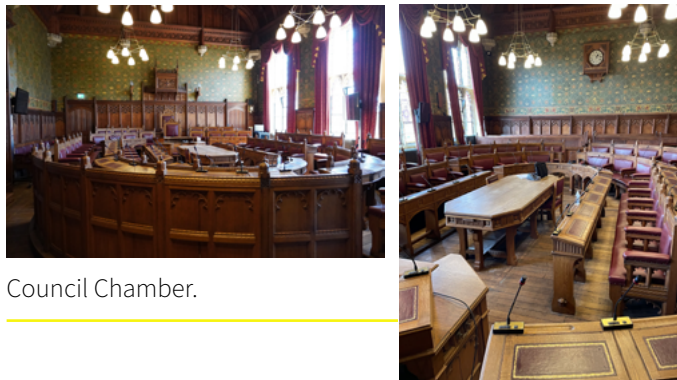
17.2.5 The floor of the chamber provides two rows of fixed wooden seating, arranged in a semi ellipse. These seats are used by elected council members. The rear row of seats is raised. These seats face the rostrum, which seats the Lord Mayor of York and the Leader of the Council, along with council officers. The rows of seating are reached via a gap between the semi ellipse and the rostrum. At approximately 600 mm wide, this gap is not wide enough to allow a wheelchair to pass through.

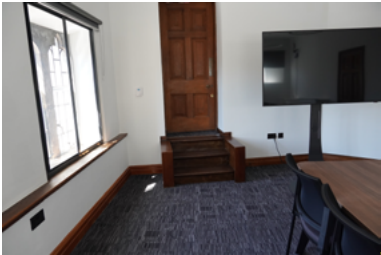
18.3	Ouse Room: the steps do not have any handrails or tonally contrasting nosings.	Provide handrails and nosings to the steps in the room. This will be subject to listed building consent.	1

<p>Steps in the Ouse Room.</p>
