Access Audit City of York Council Chambers City of York Council St Martins Courtyard Coney St York, YO1 9QL

12th August 2022

About Access Ltd

Version: Final

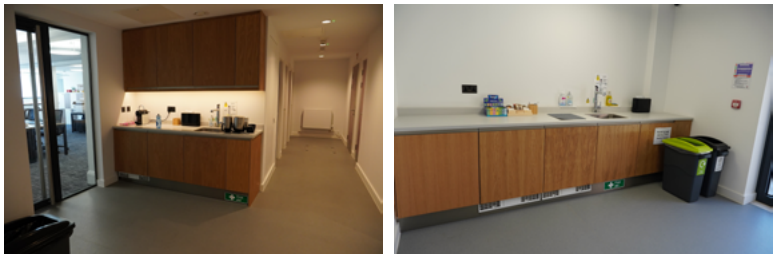
Ref	Current Findings	Recommendation	Priority
12.5	The doors provide the recommended clear effective width (CEW).		
12.6	There is good tonal contrast between floor and walls and illuminance levels meet with guidance.		
13	Kitchens		
13.1	A kitchen area can be found on all floors. The areas are all of a similar design.		
13.2	The worktops have a typical height of 900 mm above the floor. There is no knee space below any of the worktops, which is problematic for people of short stature or using wheelchairs. This can be alleviated by providing: fixed-height low sections; height adjustable sections; worktops at a height of 850 mm above the floor, which are deemed suitable for both standing and seated users.	Provide sections of worktop suitable for standing and seated users with knee space below.	2

Kitchen areas at ground and first floor.

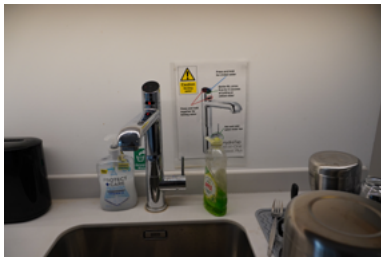
13.5	The taps are placed at the back of the worktops. The reach distance would be reduced and access improved if the taps were on the side of the worktops.	Consider repositioning tap to the side of the sinks.	P

Multi-function tap.

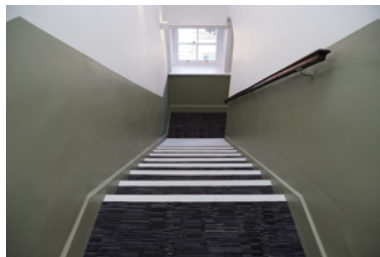
15.1 Stairs 2 provides access to the Workspace business lounge and a female toilet, this is the only single sex WC. Stair 5 provides access to the main floors.

15.2 The stairs provide uniform height risers and treads with an equal depth. Handrails are provided to one side only. Handrails should be provided to both sides of flights of steps; this allows people to use the steps in either direction, regardless of which side of their body they need to use to support themselves.

15.3 Providing a second handrail is recommended but advice should be sought from building control as this will reduce the stair width and may impede emergency evacuation.

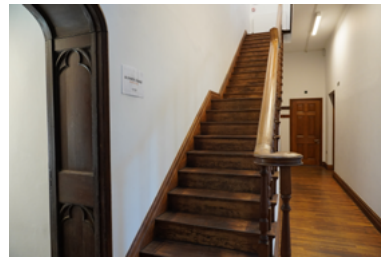
Ref	Current Findings	Recommendation	Priority
15.4	The existing handrails are at a suitable height above the line of pitch. They do not extend beyond the top and bottom steps horizontally. Altering the handrail to Stair 2 to extend is not practicable but this could be done for Stair 5.	Stair 5: provide a handrail that extends horizontally beyond the top and bottom steps for a minimum of 300 mm.	3

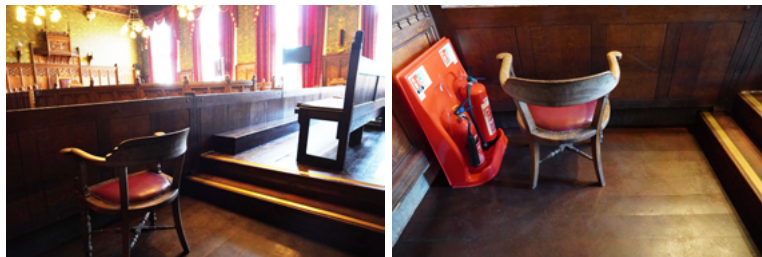
17.1.5 The recommended space for a wheelchair user is 900 mm wide x 1400 mm deep. In addition to this, there should be a manoeuvring space behind the wheelchair space of at least 900 mm but preferably 1200 mm. The minimum size for one wheelchair user will be 900 mm wide x 2300 mm (1400 mm + 900 mm) deep but preferably 2600 mm (1400 mm + 1200 mm) deep. Approved Document M recommends that there should be 1% of the total seating capacity that provides wheelchair spaces. It should then be possible to make up to a total of six spaces with removable seating. The total seating capacity of the public area of the chamber is not known. Increasing the area for wheelchair users may be feasible but of course will be subject to further investigation. Some of the fixed raised seating area in the front row could be replaced by removable seating.

View of the accessible viewing area and raised seating.

Consider removing part of the raised area and replacing with removable seating.
