VERIFICATION REQUIREMENTS FOR COVER SYSTEMS

Technical Guidance for
Developers,
Landowners and
Consultants

**Yorkshire and Lincolnshire
Pollution Advisory Group**

Version 4.1 – June 2021

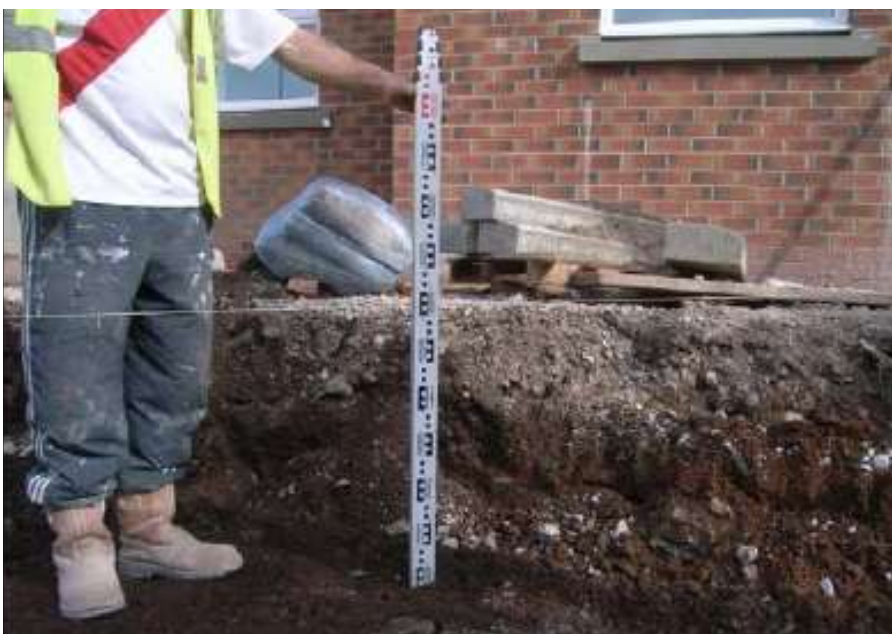
Photograph 5:
Depth check of inert cover within rear gardens. Taut string line spans across excavation.
